June 1994

ALASKA FACE Facts

Welder's Helper Asphyxiated in Argon-Inerted Pipe

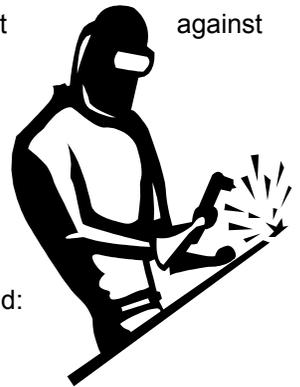
An oxygen purge system was set up in the section of pipes to be joined. This was accomplished by using a "dam system" or "pig" to isolate the pipe interfaces, filling the "pig" with argon, and welding the sections together when the oxygen was purged, as indicated by an oxygen analyzer (see figure 1). On the day of the incident, the work crew discovered that they were unable to maintain an adequate oxygen purge (possibly due to leaks and incidental oxygen in the analyzer's line hose). It is unclear if a member of the crew was assigned the sole duty of reading the oxygen analyzer. Statements by witnesses indicate that this was more likely a collective activity of the crew.

The work crew decided to replace the line to the oxygen analyzer with a shorter line connected through an access port recently welded onto the pipe (see figures 2 and 3). A welder's helper apparently entered the pipe to make this change

prior to adequate ventilation. Some time later, other work crew members could not locate the victim and became concerned when the victim's hard hat was noticed on a wooden platform beside the pipe entry point. At approximately 1:45 PM, they realized he was in the pipe and attempted a rescue. After ventilating the pipe, three workers entered a downward sloping segment of the pipeline and attached a rope to the victim. He was removed from the pipe, and CPR was initiated. He was transported to a nearby medical facility by EMTs, where he was pronounced dead at 2:28 PM. As a result of investigations by other agencies, criminal charges of manslaughter have been brought against two individuals in this case.

- ensure that all permit-required confined spaces are identified and that an appropriate system for entry/work is in place.
- ensure that all workers use appropriate confined space equipment and procedures. All workers entering a permit-required confined space must have an attached lifeline and a method for communicating with co-workers. Confined spaces must be properly ventilated prior to entry, and a "competent person" must monitor the confined space entry and work operation.
- ensure that workers entering confined spaces know the appropriate procedures to rescue an injured worker in a confined space.
- ensure that emergency medical technicians are fully trained and competent prior to assigning such employees to regular duties.
