# ALASKA FACE Facts

## Worker Struck by Multipiece Rim During Wheel Installation

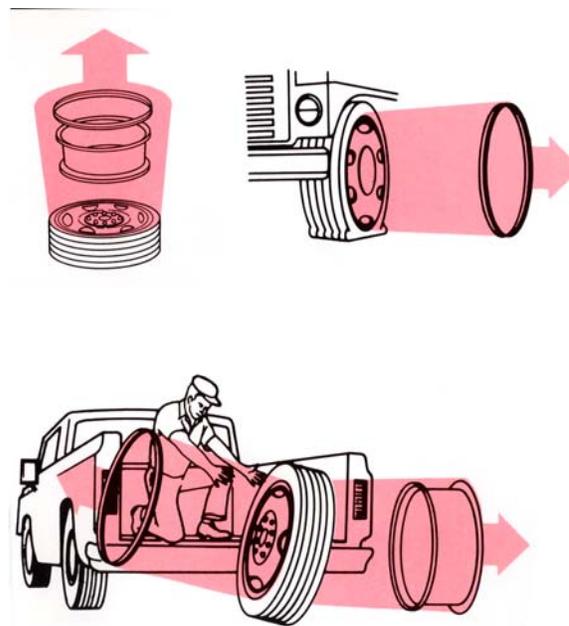
### Trajectory of multi-piece rim parts

A 23-year-old mechanic (the victim) was struck and fatally injured after the sudden release of a side ring from a multi-piece (split) rim. The victim was installing a multi-piece rim wheel that had been serviced by a co-worker the day before the incident. The wheel was remount pressurized, checked, and stored overnight inside a safety cage. The victim retrieved the wheel from the safety cage and began to install it on a dump truck. After the victim hand-tightened all six lug nuts on the spokes, he placed an impact wrench on one of the lug nuts. A co-worker walked over to the victim's location and was standing behind and to the victim's side. As the lug nut was tightened, the side ring of the rim released and struck the victim.

- ◆ Establish an inspection program for all (used and new) multi-piece rims to ensure proper matching of parts and serviceability;
- ◆ Ensure workers have been trained on proper servicing of multi-piece rims, including demounting, inspection, and mounting procedures;
- ◆ Ensure demounting/mounting procedures and rim matching charts are posted in the immediate service area per CFR 1910.177;
- ◆ Ensure a competent person inspects all multi-piece rim parts, used and new, before placing in-service, permanently removes all parts deemed unfit for use, and inspects final rim wheel assembly before installation.
