ALASKA FACE

FATALITY ASSESSMENT & CONTROL EVALUATION

Construction laborer/equipment operator crushed by skid-steer loader

FACE 01-AK-015

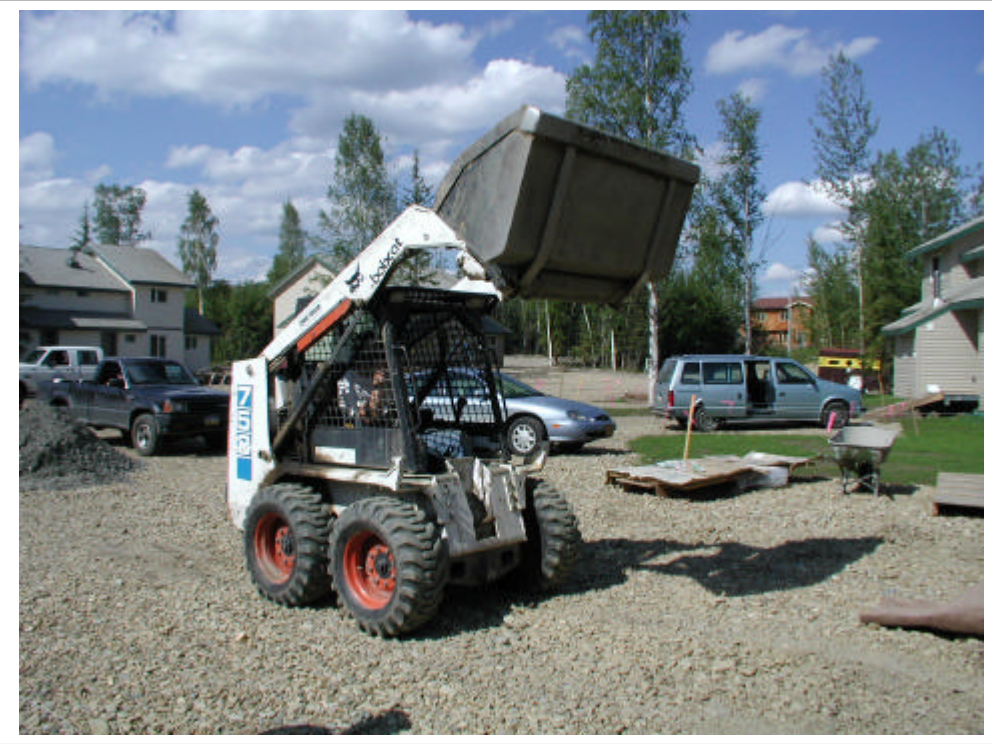
The machinery in this incident was a skid-steer loader (Figure 1). The four-wheeled unit weighs approximately 4700 pounds and has an operating capacity of 1300 pounds. It is equipped with hydraulic foot pedal-actuated lift and tilt cylinders for the bucket. Pushing forward on the lever handles to go forward or pulling back on the handles to reverse direction accomplishes movement. The unit is in a hydrostatic braking position when the handles are in neutral. It has

Discussion: While containing a load, the bucket of the skid-steer loader was raised to approximately 6 feet above ground. With no load, the majority of the weight of the loader is on the rear axles. Weight shifts to the front axle when the bucket is loaded. Balance is the key to stability. With a loaded bucket elevated to allow an operator to see under the bucket, the center of gravity is shifted forward and stability is significantly jeopardized. Operators should be aware of load limits and check the load capacity rating for the loader. In addition, operators should always keep the loader's bucket as low as possible when traveling and turning and should lift the bucket only as high as necessary to dump a load.

Figure 1. Skid-steer loader with raised bucket

Recommendation #1: Employers should ensure that workers are knowledgeable of manufacturer recommended operating procedures and safety practices for equipment that they are assigned to operate.
